INDOOR AIR QUALITY ASSESSMENT

**Alcott Elementary School
91 Laurel Street
Concord, Massachusetts**

Prepared by:
Massachusetts Department of Public Health
Bureau of Environmental Health Assessment
February, 2002

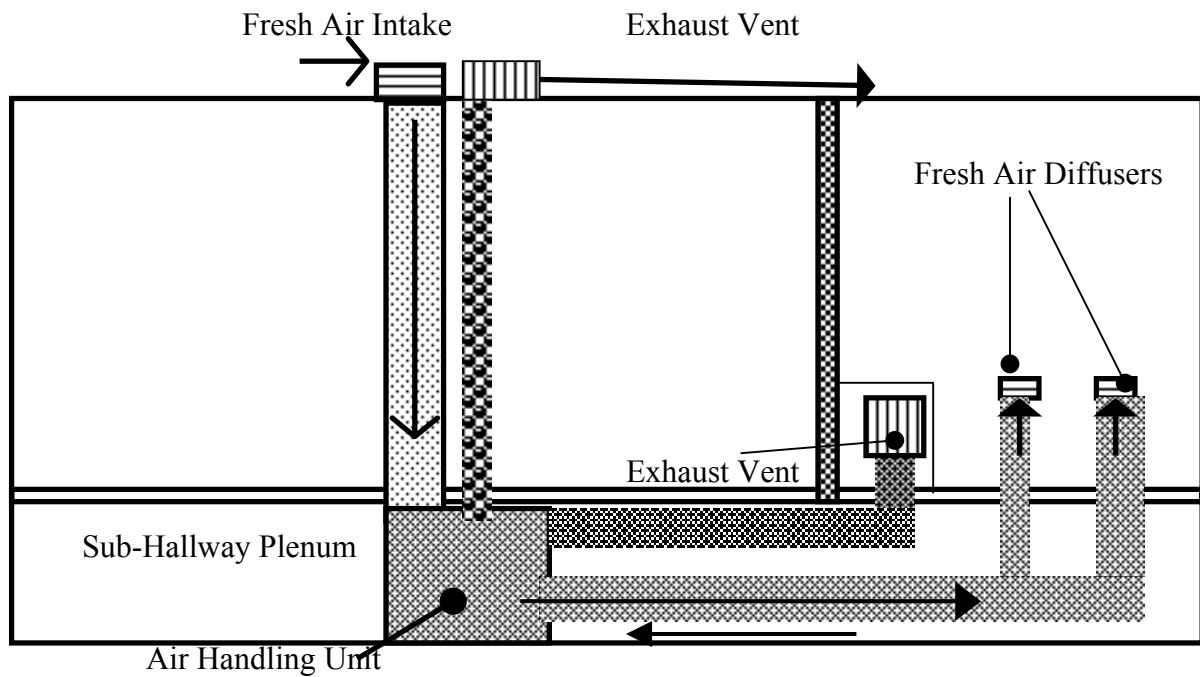
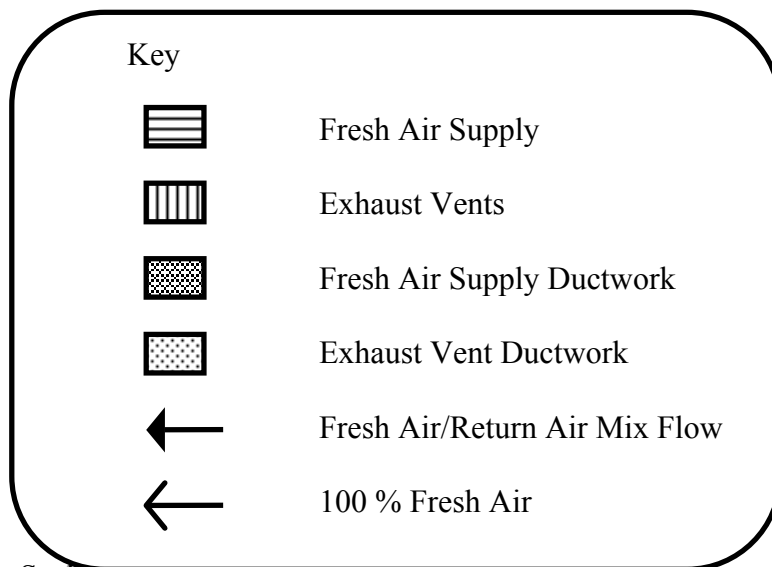
Figure 1
Probable Configuration of Airflow in 1-3 Wing and K Wing

Fresh air is supplied to the 1-3 wing and K wing classrooms by cabinet mounted fresh air diffusers (see Picture 1) that are connected by ductwork to an air handling unit (AHU) in the crawlspace (see Figure 1). All fresh air diffusers were ejecting air during this assessment. In most classrooms, however, these vents were blocked with paper, boxes, books and other obstructions. In order for these vents to provide air, they must remain clear of obstructions.

Of note is the configuration of the foundation walls of this wing. Crawlspace foundation walls are customarily equipped with passive air vents to allow for air movement into the space. The 103 wing has no crawlspace vents. This condition may allow for water vapor to accumulate and either penetrate into occupied areas through spaces around utility/heating pipes or other floor penetrations or to be drawn into the return air ducts through spaces in the sheet metal. Return air vents are depressurized, which would serve to draw crawlspace air into the duct air stream. Water vapor may then

be recirculated into classrooms by the AHU. If this condition exists, operation of the AHU during the summer months can serve to increase relative humidity inside the 1-3 wing, resulting in the wetting of carpeting.

1. Render holes through the 1-3 wing floor airtight with a sealant compound.
2. Seal each joint on the return ducts in the crawlspace to prevent crawlspace air and moisture entrainment. Be sure ***not*** to use duct tape. Use duct mastic to permanently seal duct joints. Duct tapes tend to lose adherence and should only be used as an interim/emergency measure.
3. Identify the purpose of the trench in the 1-3 wing crawlspace floor. If no purpose is identified for the trench, seal it with appropriate materials that will adhere to existing floor materials. If purpose is identified, use appropriate methods to minimize water penetration.

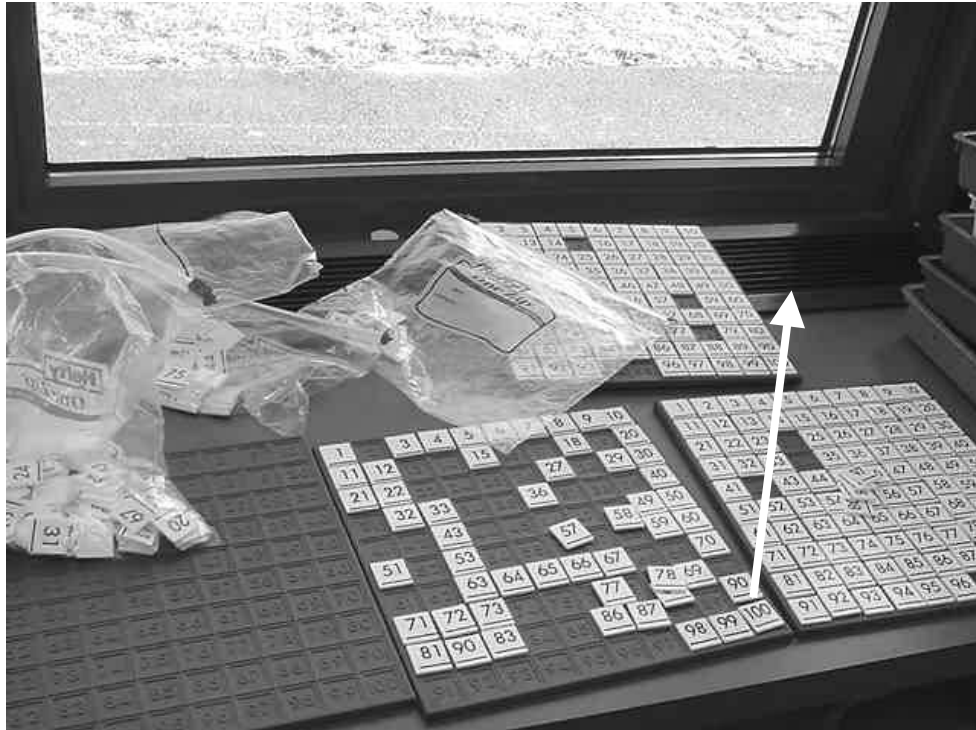
Picture 1

Fresh Air Supply Vents Typical Of the 1-3 And K Wings

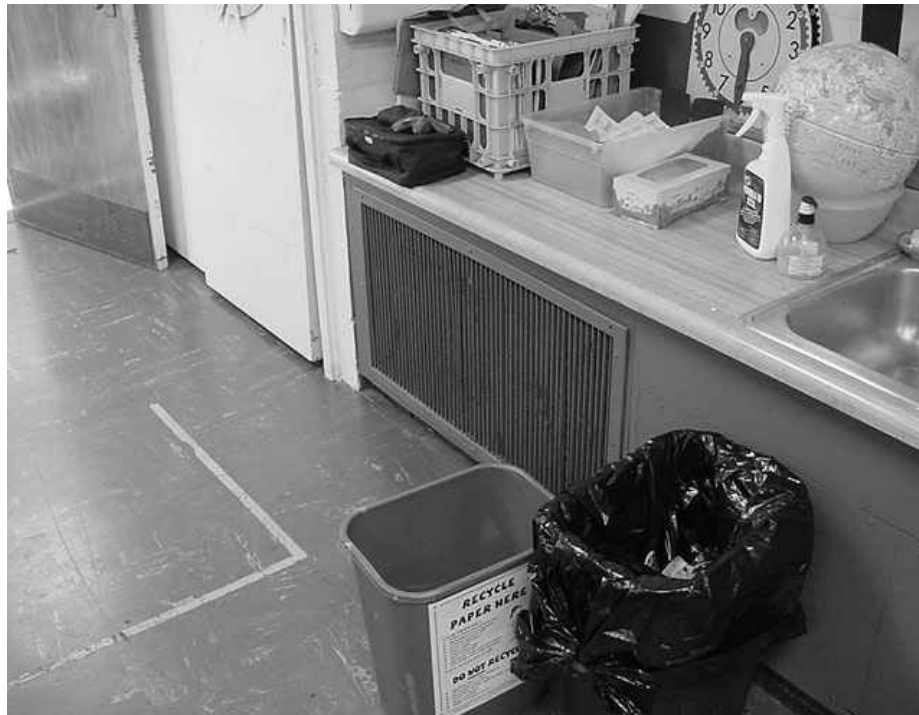
Picture 2

Exhaust ventilation in the 1-3 and K wings is provided by a grill located in sink cabinets (see Picture 2). These grills are also connected to the crawlspace AHU by ductwork. All exhaust vents in these wings were drawing air during the assessment.

Exhaust Vents Typical Of the 1-3 Wing

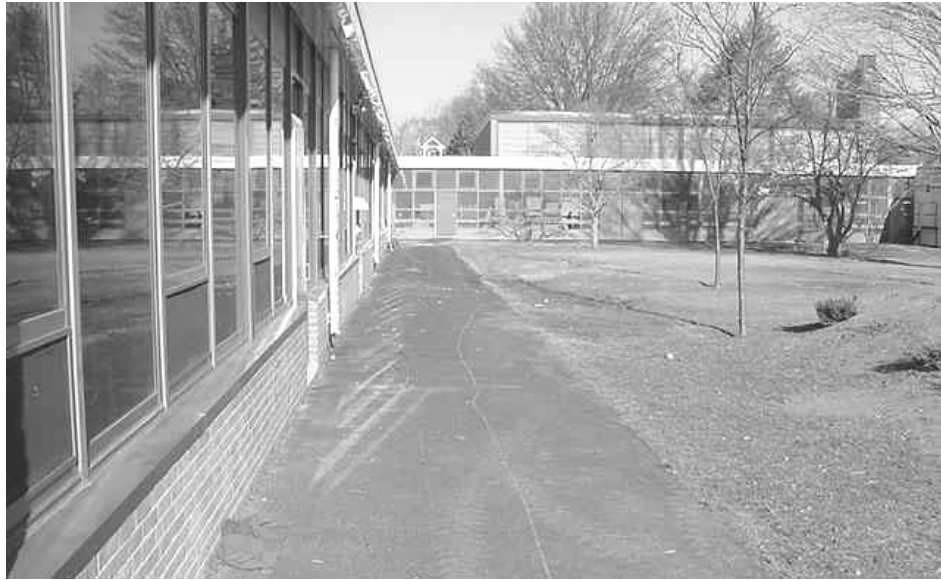
Picture 3

1. Rainwater from the roof of the building is directed into a downspout system that empties onto a tarmac apron surrounding the exterior wall of this wing. The tarmac apron appears to be sloped *towards* the foundation (see Picture 3), allowing rainwater to come into contact with the exterior wall tarmac junction. Over time, this process can undermine the integrity of the building envelope and provide a means of water entry into the building through capillary action through foundation concrete and masonry (Lstiburek & Brennan, 2001). This condition may also allow for water to gather beneath the crawlspace floor. This condition does not exist in the 3-5 wing. The tarmac apron surrounding the 3-5 wing is sloped away from the exterior walls

of the wing, which prevents water pooling. Building occupants report that the 1-3 wing tarmac is prone to icing during the winter.

Tarmac Apron around 1-3-Wing, Note Location of Downspout Termini at Base of Building

1. Examine the feasibility of re-paving the tarmac apron around the 1-3 wing to have it slope away from the edge of the building in a manner similar to the 3-5 wing tarmac apron. Once done, apply an appropriate sealant to the seam between the tarmac and building exterior wall.

2. Consideration should be given to extending the downspouts in a manner to empty rainwater at least 5 feet from the foundation wall to prevent water entrainment.

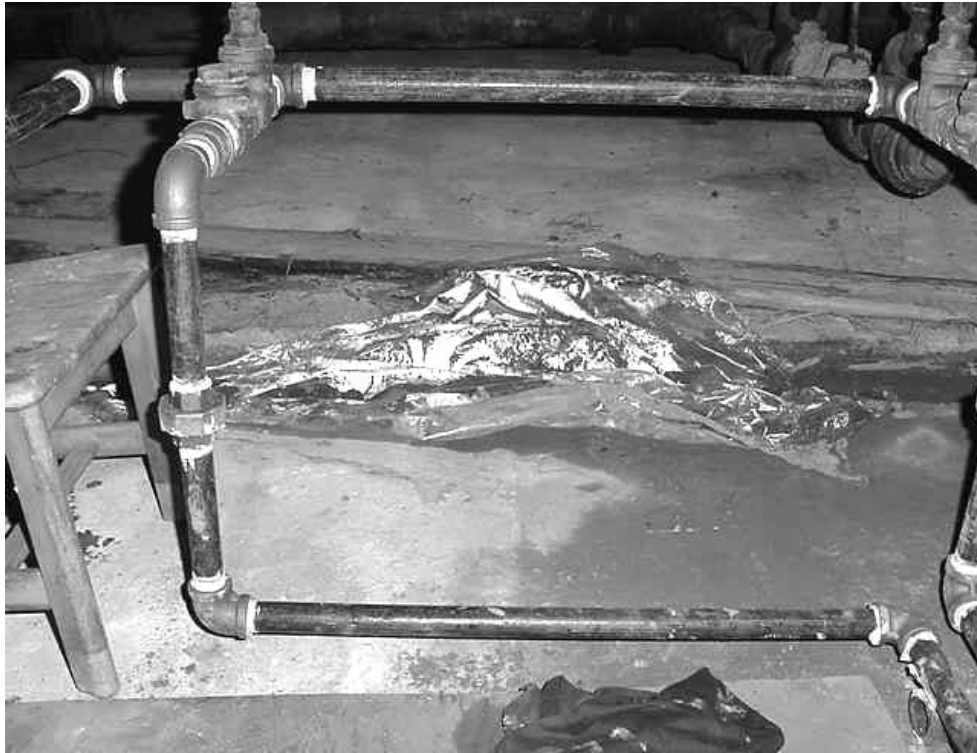
Picture 4

2. An examination of the crawlspace floor revealed a narrow, 20+ feet long trench in the concrete floor (see Picture 4). This trench, of unknown origin or purpose, was dirt filled and extended to the north foundation. In an effort to determine whether this trench was a source of moisture, Concord Public School (CPS) staff covered part of this trench with plastic. The side of the plastic facing the trench was heavily coated with water droplets, indicating that this trench is a moisture source (see Picture 5)

Trench In 1-3-Wing Crawlspace Floor

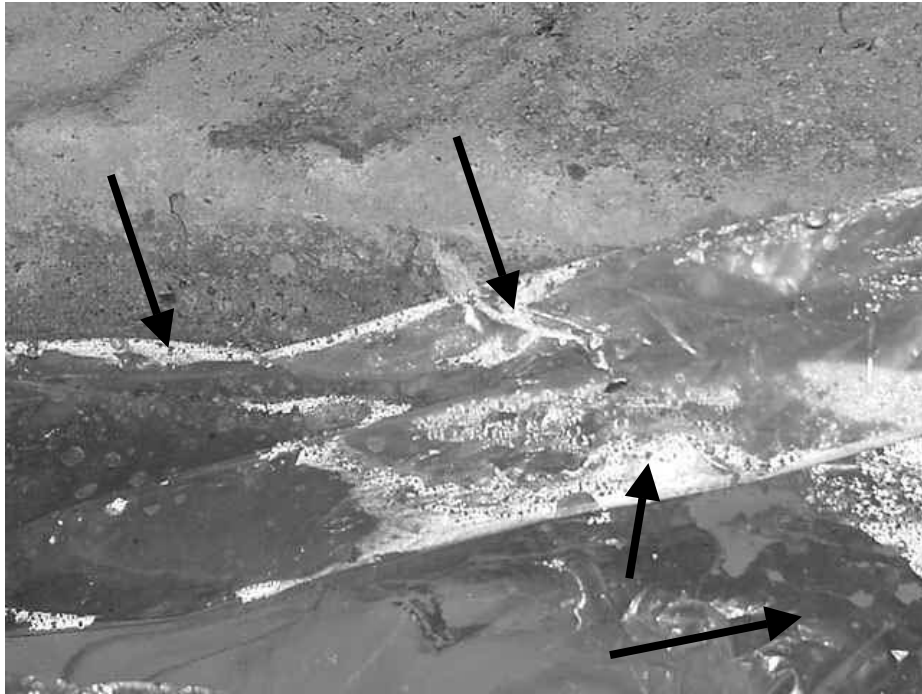
Picture 5

Plastic Covering the Trench in Picture 4, Note Beaded Water

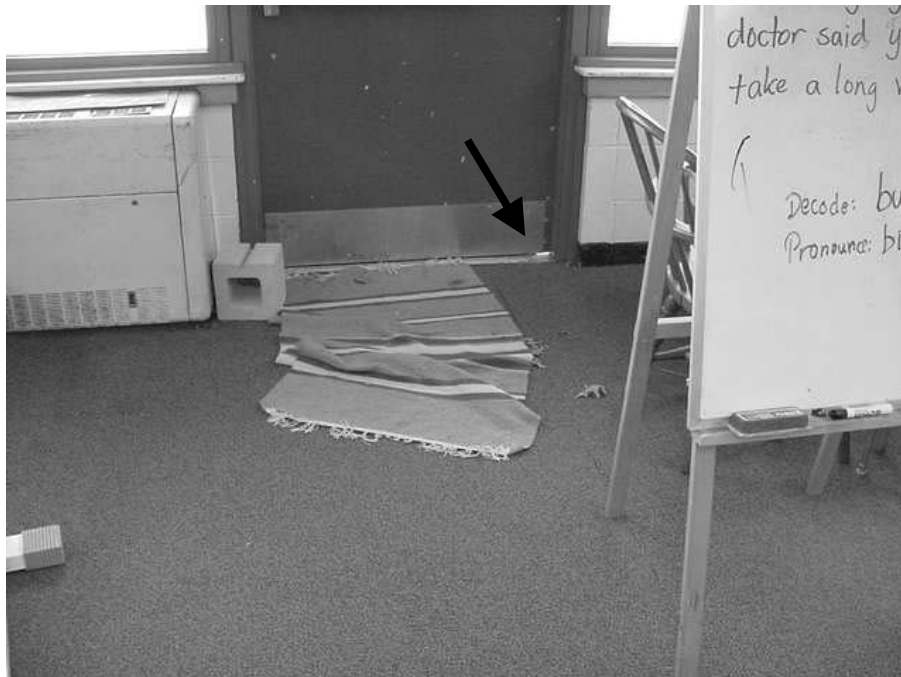
Picture 6

4. Another possible contributing factor to water vapor penetration is through kindergarten exterior doors. A space in the doorframe exists, through which outdoor light could be seen (see Picture 6).

Space Beneath Classroom Exterior Door, Note Light

4. Examine pipes in 1-3 wing crawlspace for steam pipe leaks and repair if leaks are present.
5. Render classroom exterior doors airtight by eliminating spaces between doors and frames.
